# POSEIDON<sup>®</sup> ST

## Expandable Vertebral Body Replacement

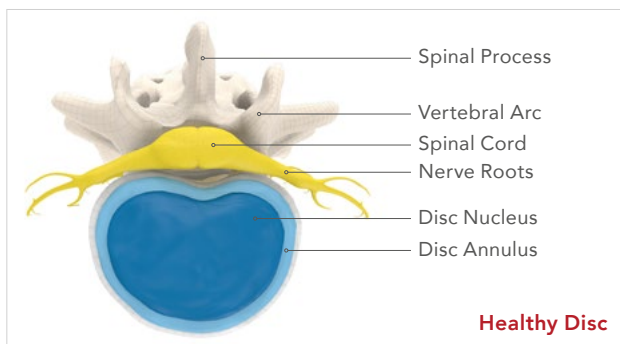
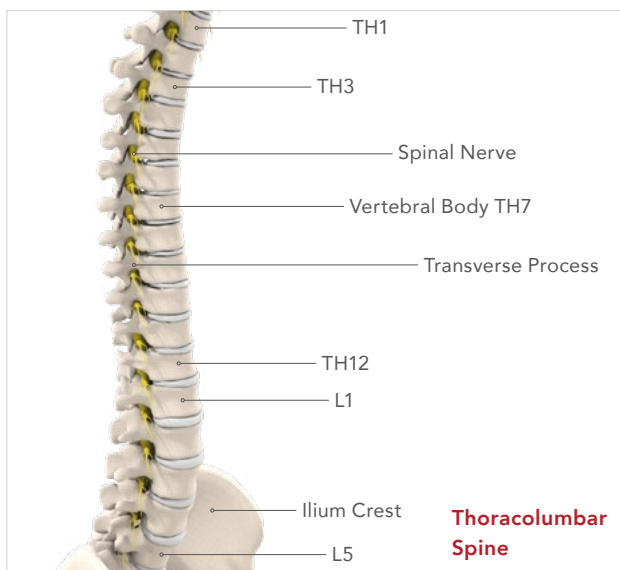
The thoracic spine is the second segment of the vertebral column, located between the cervical and lumbar vertebral segments. It consists of 12 small bones (TH1–TH12), called the thoracic vertebrae.

The lumbar spine (low back) is the third major region of the spine. It is below the cervical and thoracic spine and consists of 5 small bones (L1–L5), called the lumbar vertebrae. Each vertebra is stacked on top of the other and between each vertebra is a jelly-like cushion, called an intervertebral disc. The discs help to absorb pressure, distribute stress, and keep the vertebrae from grinding against each other.

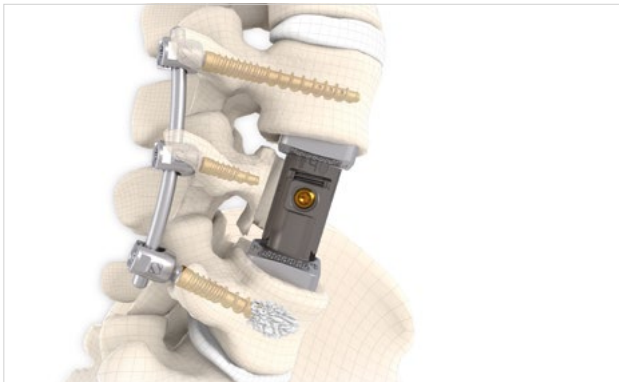
Vertebral Body Replacement

If these symptoms cannot be resolved or adequately eased, then an operation may become necessary. In this case, the related vertebrae has to be removed and replaced by an implant so that the stability of the spine can be maintained. So that these implants are stably anchored, the top and bottom of the implant are placed directly on the neighbouring vertebral bodies and not the discs. Therefore adjacent discs are also removed, before placing the implant.

When replacing a vertebral body there is always an additional fixation required. Therefore your surgeon might decide to also implant fixing screws (pedicle screws) from the back. Depending on the surgeons' choice of access, this screw-rod-system will be implanted in one step with the implant. If a second step is needed, your surgeon might either way decide to turn you around during the operation to place the screws or to do these two steps in two different surgeries (within approx. two weeks).

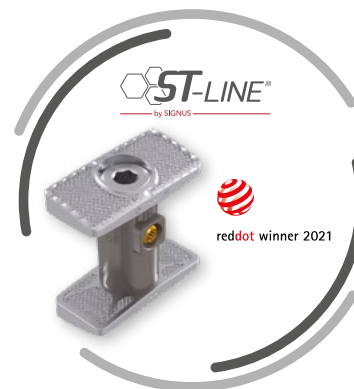
POSEIDON® ST is a vertebral body replacement implant for use in the spine. The implants serve as temporary placeholders to restore the spine until firm bony fusion has taken place. They are not explanted again but remain in the patient. The implants are available in various designs, footprints, heights and angles to enable adaptation to different patient anatomies. The implant consists of one main body, which is expandable within the patient to obtain the needed height according to the patients' anatomy. Various endplates of different footprints and angles are mounted on both sides of the main body for maximal cortical contact and therefore maximum stability of the implant.

The implants are made from the following materials:  
Titanium alloy (TiAl6V4) as per ASTM F 136 / ISO 5832-3
